Re: City of Whitehorse Detailed Salmon Habitat Management Plan – Final Deliverables

Please find enclosed the final deliverables associated with Project # CRE-71N-03: Detailed Salmon Habitat Management Plan for the City of Whitehorse, Yukon. Seven hard copies of the final report will be delivered to your office with the following digital deliverables:

Table of Contents

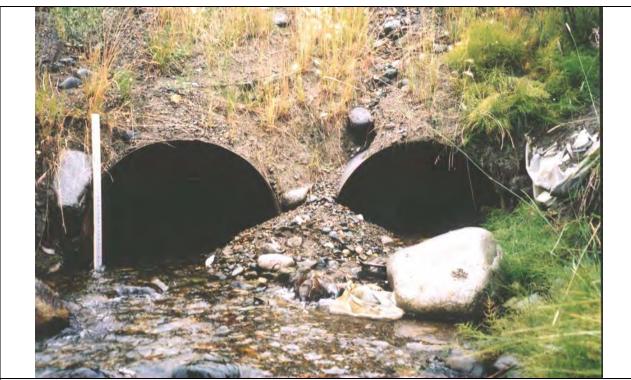
Plate 1. Culverts on Little Takhini Creek across the North Klondike Highway

There are a total of three stream crossings on Little Takhini Creek. The first crossing contains two embedded, oval, corrugated metal culverts approximately 40m long across the North Klondike Highway (Plate 1) on reach 5 of Little Takhini Creek. This set of culverts was considered a potential barrier to the upstream passage of juvenile chinook (AEM 2003). In an attempt to determine the status of these culverts as barriers to fish passage, fieldwork was conducted during the summer of 2003 to provide more detailed information following the culvert inspection procedures outlined in Parker (2000). Culvert measurements for this culvert were taken on August 29, 2003 and are outlined in Table 1. Based on the results of this more detailed assessment, the culverts across the North Klondike Highway on Little Takhini Creek do in fact present a barrier to the upstream passage of all fish species and age-classes due to their length and water velocity, i.e., 40m length culverts and minimum water velocity of 0.94 m/sec exceeds the swimming abilities of adult chinook (Parker 2000). Since adult chinook are the strongest swimmers, juvenile chinook and individuals of other fish species, if they were to occur at this point in the stream, would not be able to pass through these culverts (Parker 2000). Plate 1 also shows that the fill slope above these culverts is a source of sediment into Little Takhini Creek.

Characteristics of the channel downstream of the culverts taken on August 29, 2003 are outlined in Table 2. Approximately 35m downstream of the culverts across the North Klondike Highway on reach 5 of Little Takhini Creek is an obstruction to fish passage (UTM Zone 8 NAD83: 0488873E 6741737N). Old culvert materials lie in pieces within the creek and create a step of approximately 47cm outfall height (Plate 2). Juvenile chinook documented to occur on this reach would not be able to pass this obstruction.

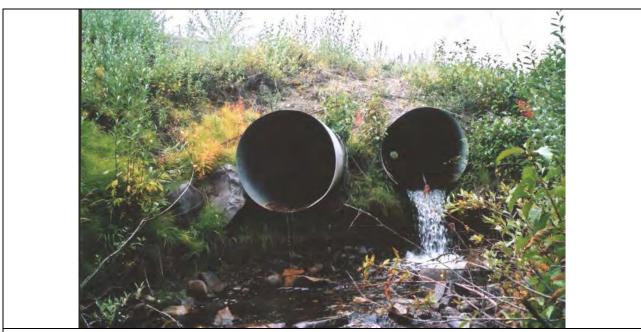
Plate 3. Culverts on Little Takhini Creek across the Alaska Highway

The second set of culverts on Little Takhini Creek are two perched, round, corrugated metal culverts approximately 70m long across the Alaska Highway (Plate 3) on reach 5. Culvert measurements for these structures were taken on August 29, 2003 following culvert inspection procedures outlined in Parker (2000) and are outlined in Table 3. The results of this more detailed assessment confirms that these culverts present a barrier to the upstream passage of fish on reach 5 of Little Takhini Creek due to the large outfall drop as well as the culvert length (70m) and water velocity (4.20m/sec).

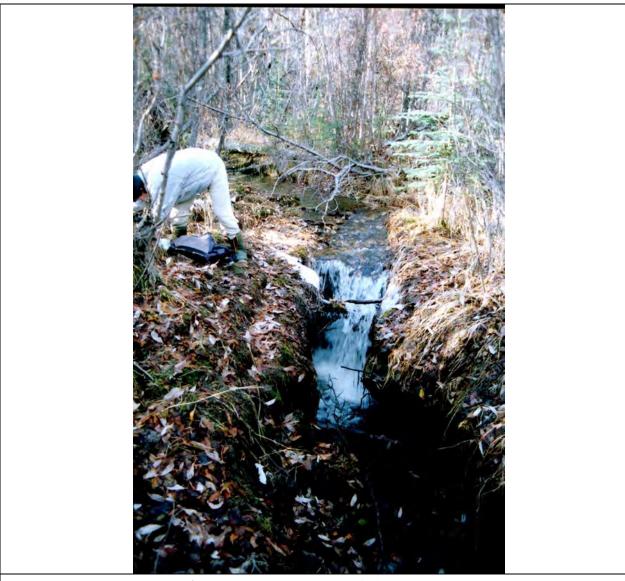
Plate 4. Natural Step on Reach 7 of Little Takhini Creek

The third stream crossing on Little Takhini Creek lies above the natural obstruction on reach 7; it is not known whether this crossing presents an obstruction to fish passage, the site was not field investigated.

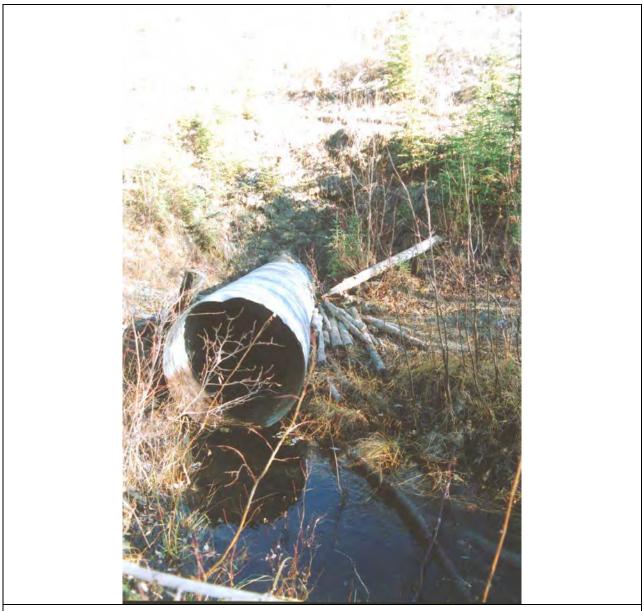
Plate 5. Culvert on Nine Mile Creek across Trail beside the Alaska Highway

The third culvert on reach 2 of Nine Mile is a source of sedimentation into the creek (Plate 5). The culvert lies across a trail used for motorized and non-motorized recreation. It is suggested that either the culvert be replaced with a small bridge or a boardwalk following guidelines outlined in Forest Practices Code, Fish Stream Crossing Guidebook (2002) or the trail be deactivated. Restoration activities should adhere to Fisheries Act and Yukon Waters Act regulations and be conducted under the auspices of the appropriate regulatory authorities, i.e., DFO and YTG.

In the absence of culvert restoration, it is suggested that the culvert on Nine Mile Creek across the trail beside the Alaska Highway be selected as a focal site for water quality testing (especially sediment testing) due to the presence of the improperly installed culvert. However due to the absence of chinook in this stream and the lack of information on the presence of freshwater fish, this should be considered of moderate priority.

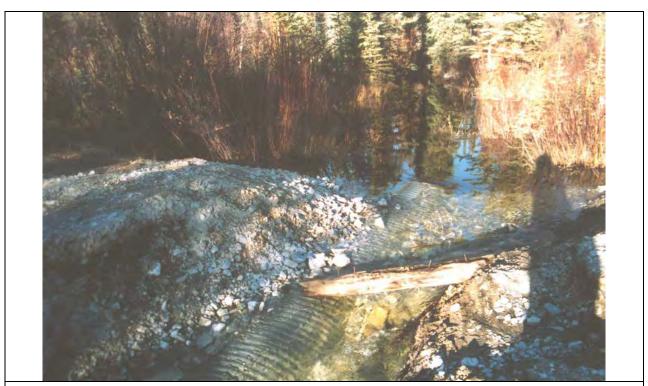
Plate 7. Culvert on Croucher Creek across Livingstone Trail October 2002

There are three stream crossings on Croucher Creek. The first is a bridge on the Sewage Lagoon Road across the mainstem of Croucher Creek and the second is a culvert on reach 1 of the south fork across Livingstone Trail. Neither of these structures presents a barrier to fish passage (AEM 2003). The third stream crossing is an improperly installed culvert on reach 2 on the north fork of Croucher Creek (AEM 2003). This culvert is currently washed out and has the potential to release sediment into areas used by rearing chinook, affect downstream morphology and present an obstruction to fish passage. Plate 7 shows the status of this culvert in the summer of 2002 and Plate 8 (summer 2003) shows how much road materials have been washed into the creek since 2002. Summer 2003 fieldwork provides more detailed sampling of this site following culvert inspection procedures outlined in Parker (2000). Culvert measurements for both culverts taken on August 30, 2003 are outlined in Table 11.

² Culvert collapsed and depressed in the middle, therefore an accurate culvert slope could not be determined

³ Fill slope washed away
