### Government of Yukon Community Services, Land Development

### Phase I Environmental Site Assessment Lot 519 and 520 Copper Ridge Whitehorse, Yukon

# COPPER RIDGE LOT 519 & 520 MUNICIPAL SERVICING ASSESSMENT

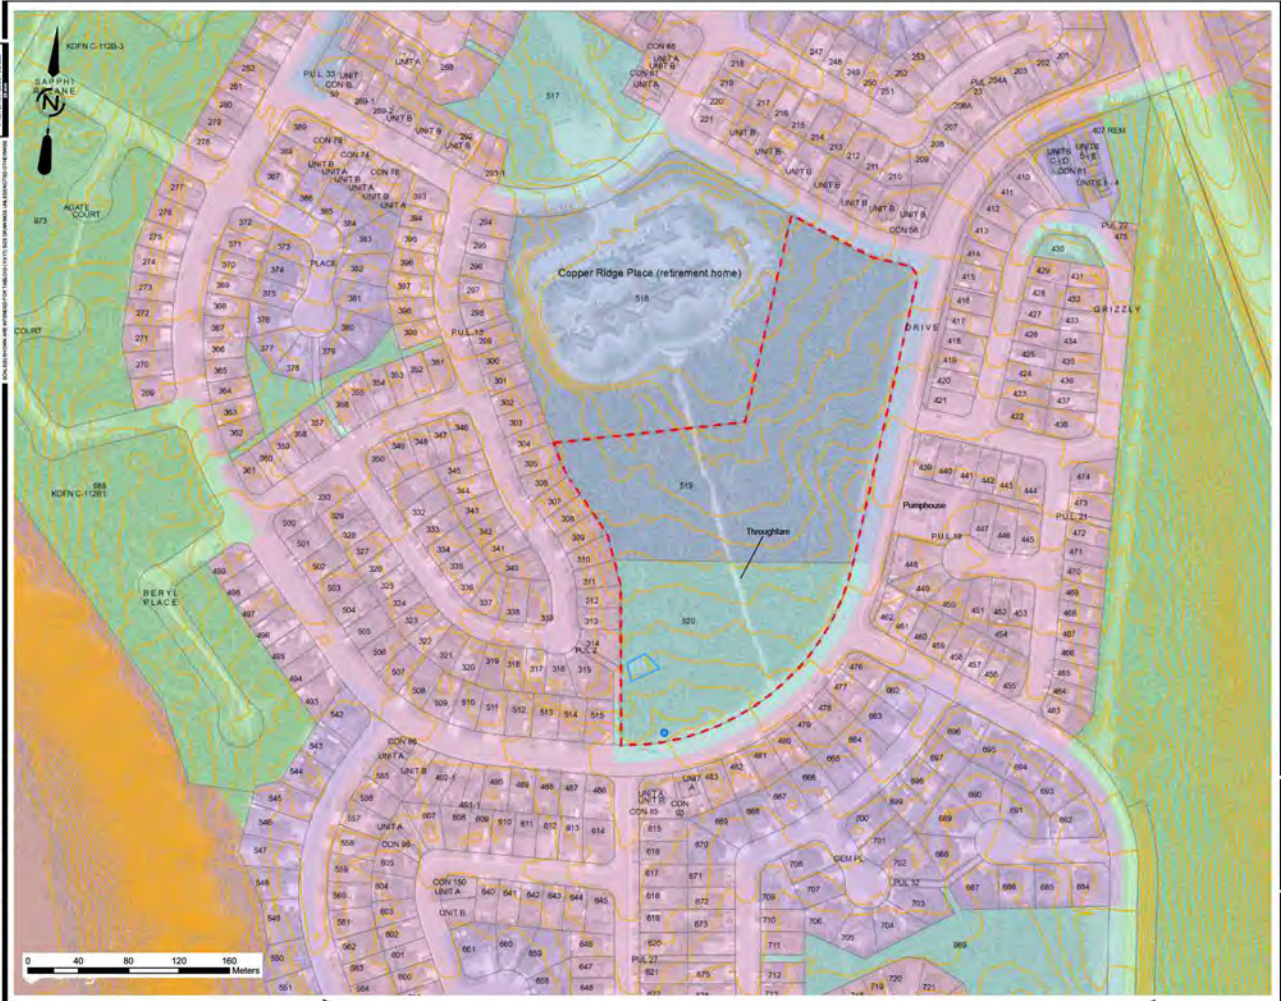
**FIGURE 2**  
PHASE I ESA'S COPPER RIDGE, HILLCREST AND  
HEMLOCK WHITEHORSE YT  
COPPER RIDGE LANDUSE

- Legend:**
- Subject Site Boundary
  - Elevation
- Land Use**
- FP Future Planning
  - PE Environmental Protection
  - PG Greenbelt
  - PR Parks and Recreation
  - PS Public Services
  - RM Residential Multiple Housing
  - RR Restricted Residential Detached
  - RS Residential Single Detached
- Groundwater well
  - Surface water drainage ditch
  - Inferred groundwater flow: east to northeast

The grounds at the Subject Site are described in Table 9-1. Key features observed are shown in Figure 2.

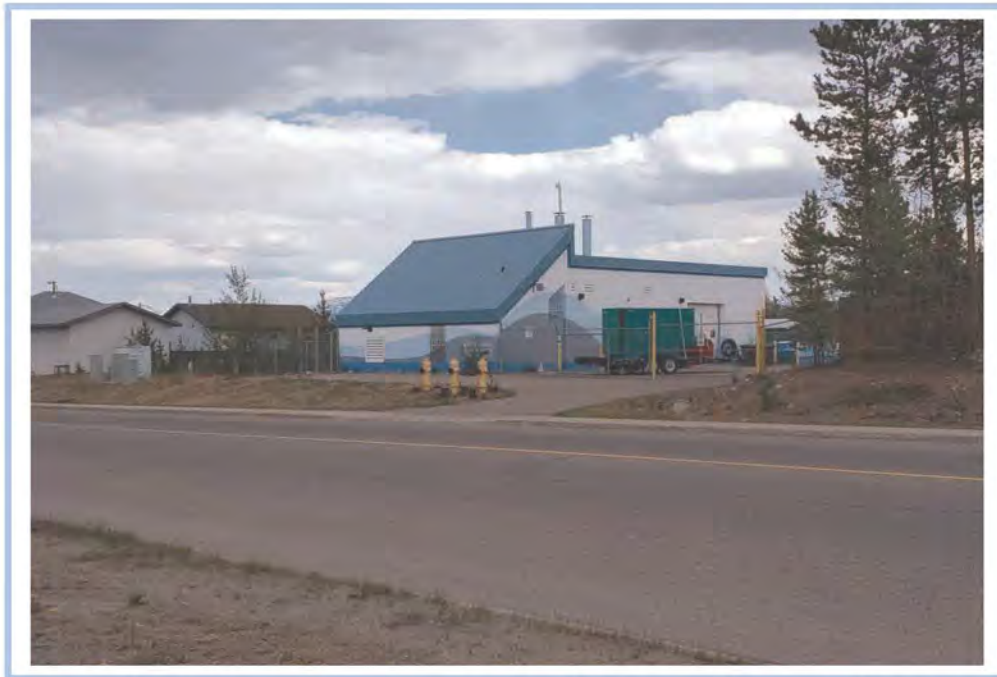
**Photograph 1:** Pumphouse located on Falcon Drive to the south of the Subject Site (looking southeast) (June 3, 2022).

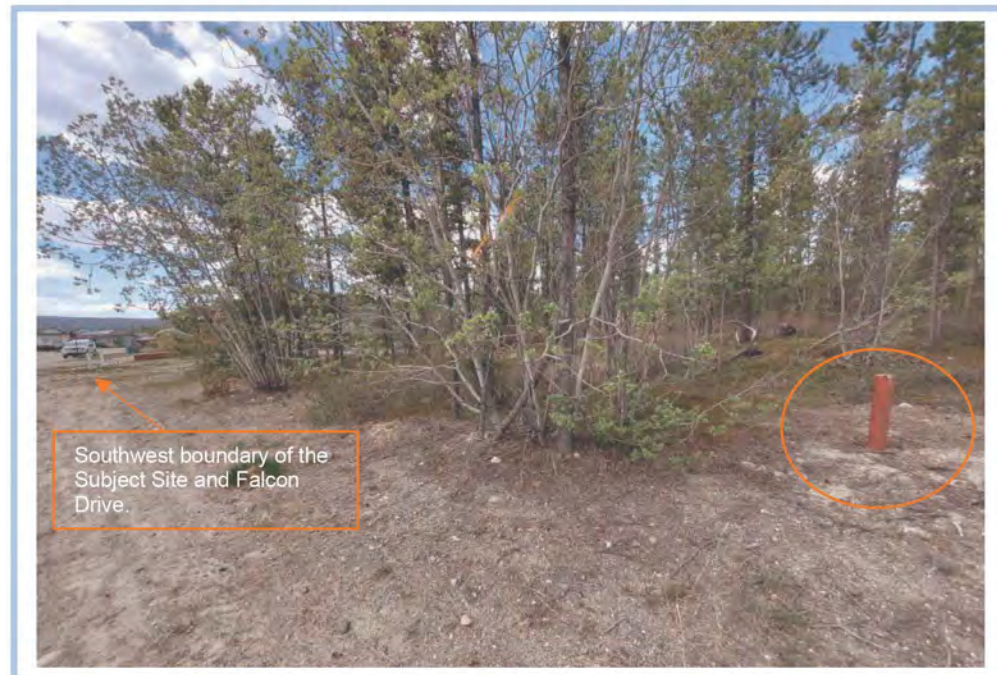
**Photograph 2:** a groundwater monitoring well (circled), was observed in the southwest of the Subject Site and close to Falcon Drive in the south. The well was locked. (June 3, 2022).

Groundwater wells	One groundwater monitoring well was observed the southwest of the Subject Site (on Lot 520), close to Falcon Drive ( <i>photograph 2</i> ).
Non-hazardous waste generation and handling	Waste is not being generated on the Subject Site.
Hazardous materials/chemical and fuel storage	None observed.
Drains/Sumps/Oil water separators	None observed.
Pits, lagoons	None observed.
Wastewater or other discharges	None observed.
Surface waterbodies, ditches or standing water	A rock pit was observed in the southwest corner of the Subject Site (on Lot 520) ( <i>photograph 4</i> ). The pit was dry at the time of the site visit. The pit receives and temporarily holds excess stormwater from adjacent residential properties, which infiltrates into the underlying soil.
Drainage	Surface water drainage is through infiltration into underlying soils.

An on-site groundwater well was observed in the southwest (on Lot 520). The well is not listed on the Water data catalogue (Government of Yukon. 2022d.) or the Groundwater water well registry (Government of Yukon. 2022b) however, based on discussions with the City of Whitehorse Water & Waste Services, it is understood that the well is used to assess local groundwater (flow and level monitoring) and the performance of the rock pit on Lot 520, which receives surface drainage from the residential properties to the west of the Subject Site. The City of Whitehorse advised that any future development on the Subject Site will need to consider surface water drainage and the incorporation of the monitoring well and rock pit located on Lot 520.

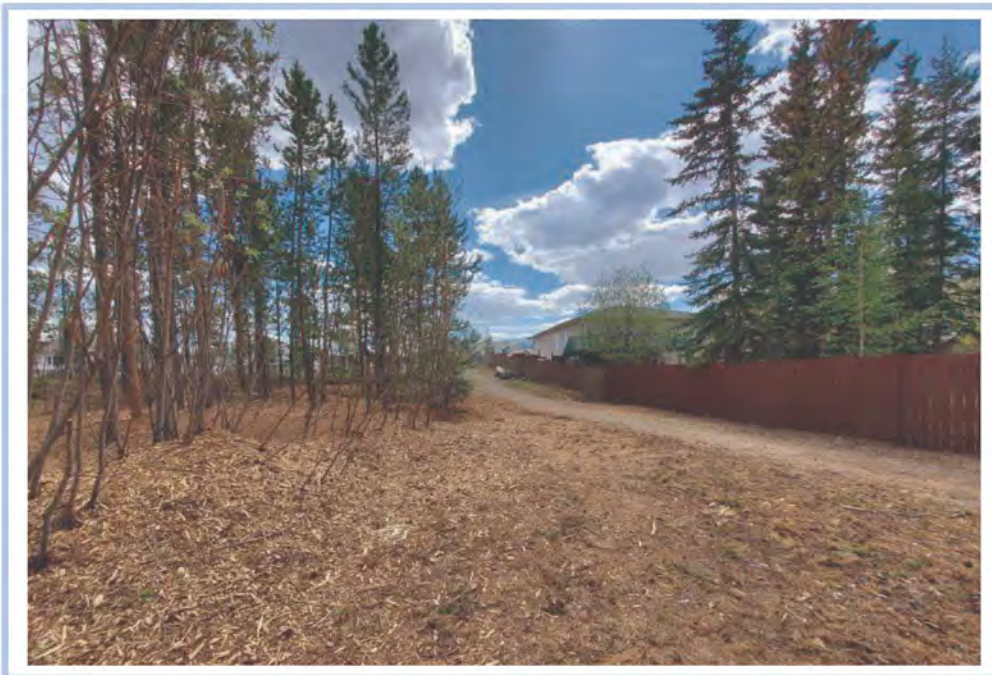
**Photograph 3:** a dirt trail in the west is used as a throughfare between Falcon Drive and residential buildings on Tigereye Crescent (June 3, 2022).

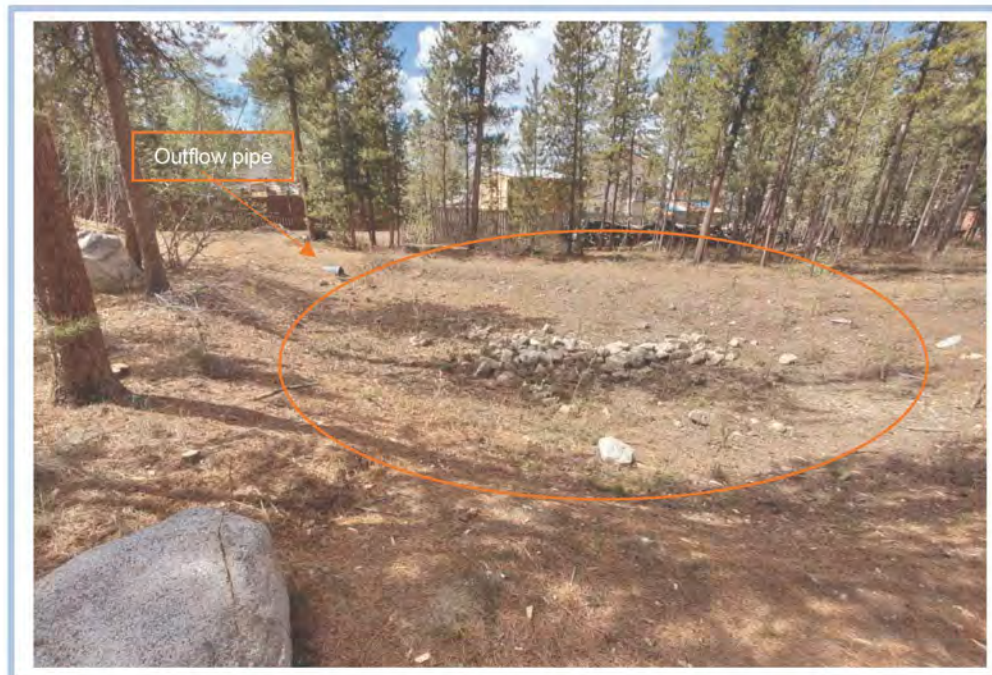
**Photograph 4:** Surface water drainage ditch with outflow pipe (circled) located in the southwest corner of the Subject Site (looking west) – source of water from drainage pipe is unknown (likely from the south) (June 3, 2022).

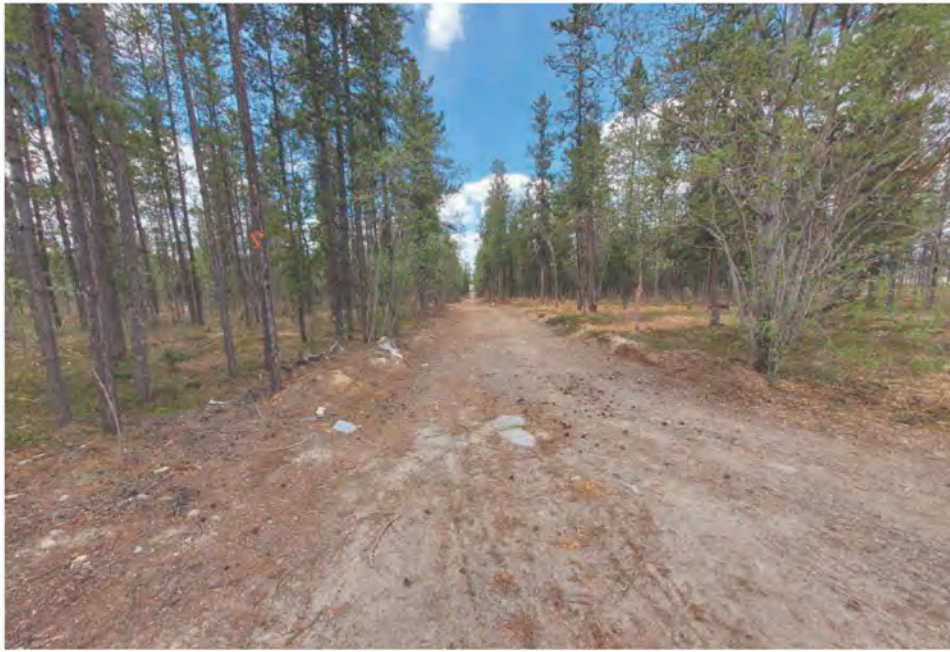
**Photograph 5:** a throughfare goes though the Subject Site between Falcon Drive and Copper Ridge Place (retirement home), (looking north from the southern boundary of the Subject Site) (June 3, 2022).

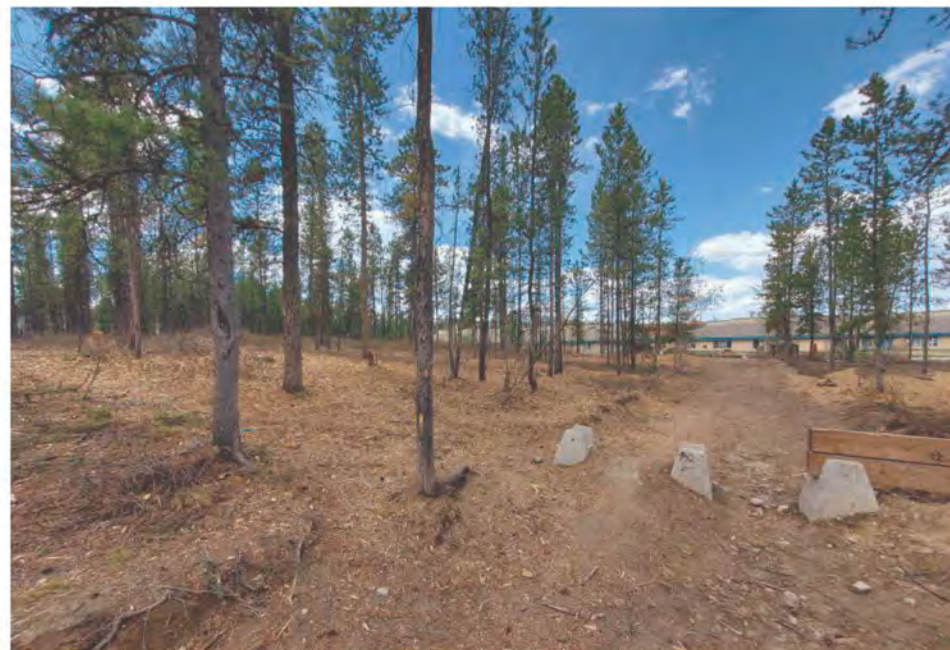
**Photograph 6:** Copper Ridge Place located north of the Subject Site (looking north) (June 3, 2022).

Direction Relative to Subject Site	Description
North (Inferred cross-gradient)	<b>North adjacent:</b> <ul style="list-style-type: none"> <li>- Vacant vegetated land</li> <li>- Copper Ridge Place (retirement home at 60 Lazulite Road) (zoned (PS) Public Services - (Lot 518)) (photograph 6) - 160 m north</li> <li>- Diamond Way (road)</li> </ul>
	<b>Northeast adjacent:</b> <ul style="list-style-type: none"> <li>- Falcon Drive (road)</li> <li>- <u>Beyond Falcon Drive</u>: Developed residential (zoned (RS) Residential Single Detached)</li> </ul>
	<b>Northwest adjacent:</b> <ul style="list-style-type: none"> <li>- Developed with residential buildings (zoned RS)</li> <li>- <u>Beyond residential area</u>: Tigereye Crescent (road) and developed residential (zoned RS)</li> </ul>
East (Inferred down-gradient)	<b>East adjacent:</b> <ul style="list-style-type: none"> <li>- Falcon Drive (road)</li> <li>- <u>Beyond Falcon Drive</u>: Developed residential (zoned RS) and Copper Ridge Pump House (photograph 1).</li> </ul>

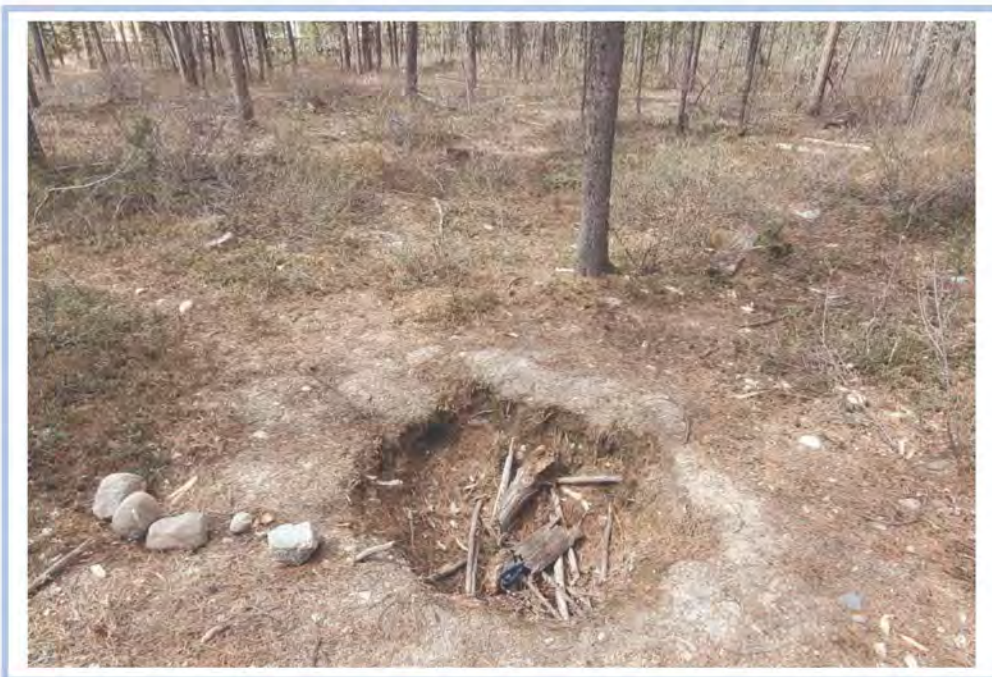
*Photograph 7: fire pits were observed on the Subject Site (June 3, 2022).*

Subject Site Grounds	Comments/Observations
Ground cover	Bare ground and vegetation, including mature trees (forested). Fire pits were observed ( <i>photograph 7 and 8 (Appendix C)</i> ).
Roads, Parking, Rights of Way	A thoroughfare dirt track is located between Falcon Drive to the south and Copper Ridge Place to the north ( <i>photograph 5</i> ).  There are also several smaller dirt trails throughout, which are used for recreation and as thoroughfares.
Overhead and/or underground lines	Overhead and underground utility lines surround the Subject Site.
Potential noise sources	None identified at the time of the site visit.
Vegetation	Vegetation appears to be within seasonal norms.
Visual or olfactory signs of contamination	None observed.
Fill Materials	None observed.
Storage Tanks (aboveground or underground)	No evidence of ASTs or USTs.
Evidence of underground structures	No evidence of underground structures.

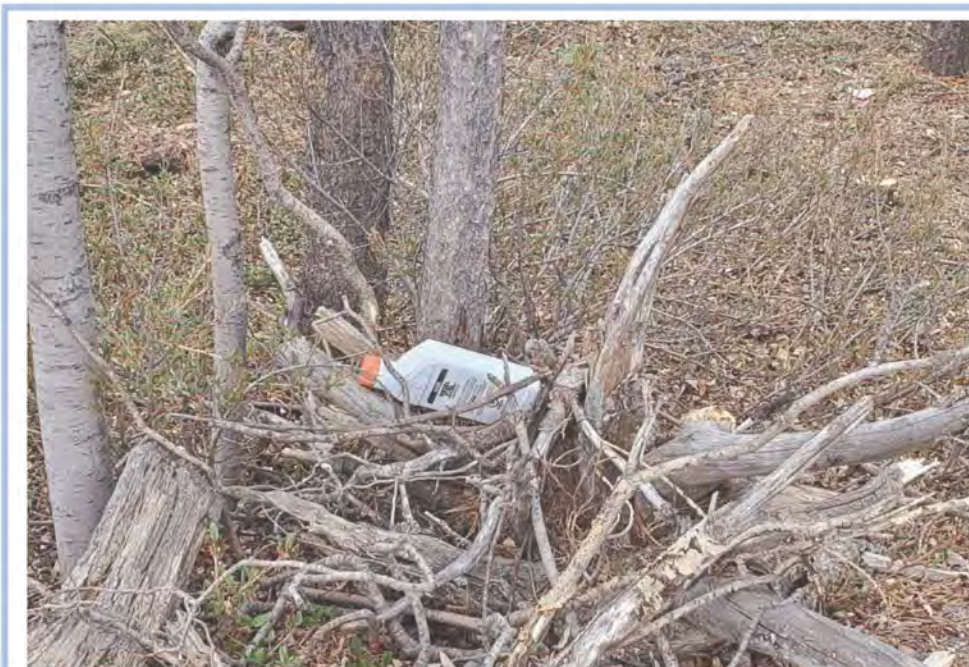
*Photograph 8: empty diesel bottles – possibly used as a fire igniter (June 3, 2022).*

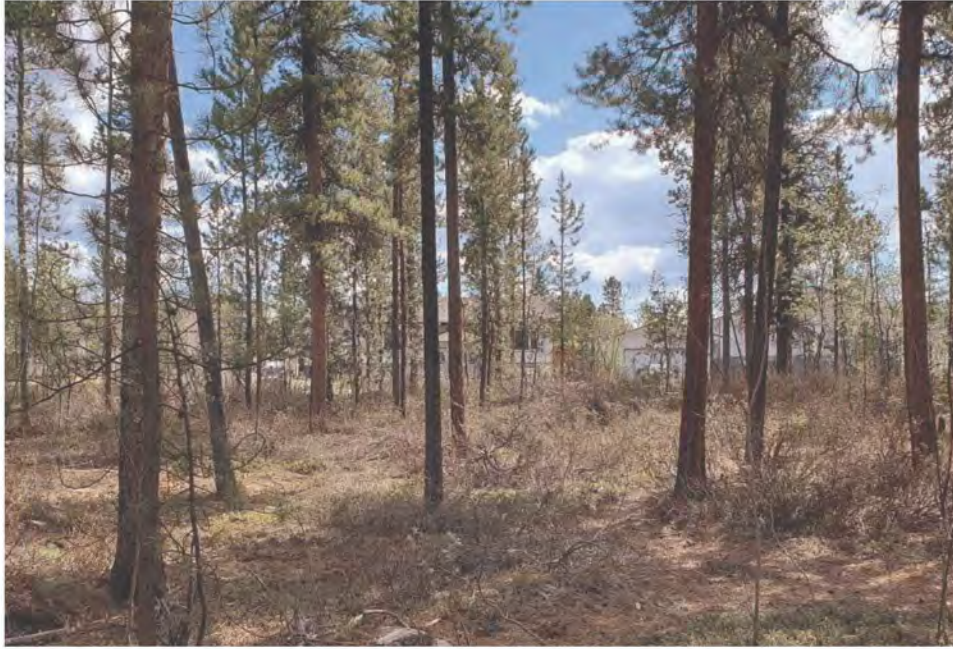
**Photograph 9:** residential properties located along the western boundary of the Subject Site (looking west) (June 3, 2022)

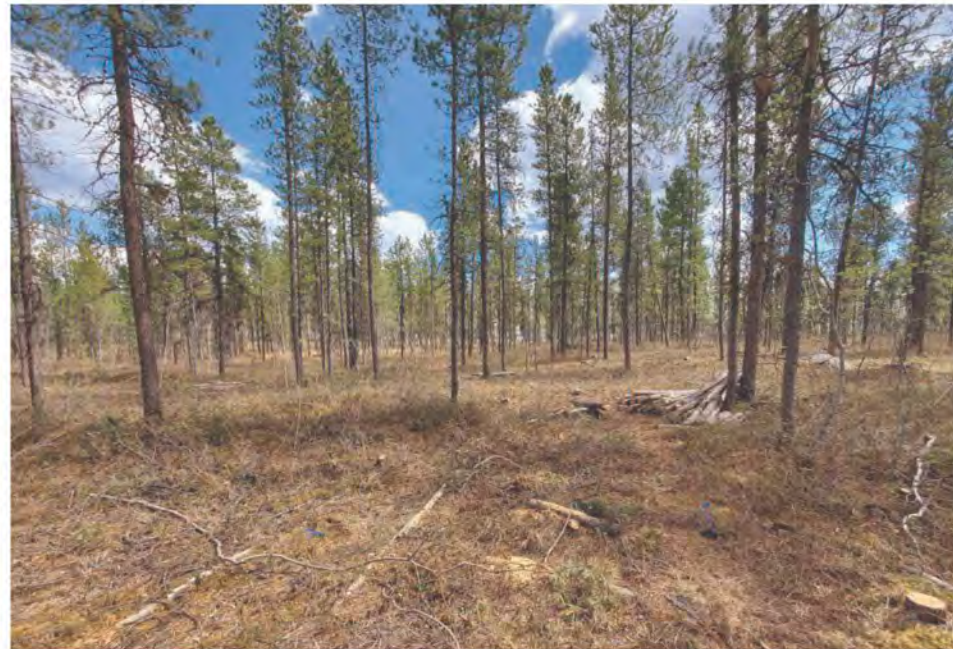
**Photograph 10:** areas have been cleared, with stacked log piles seen on the Subject Site (June 3, 2022)

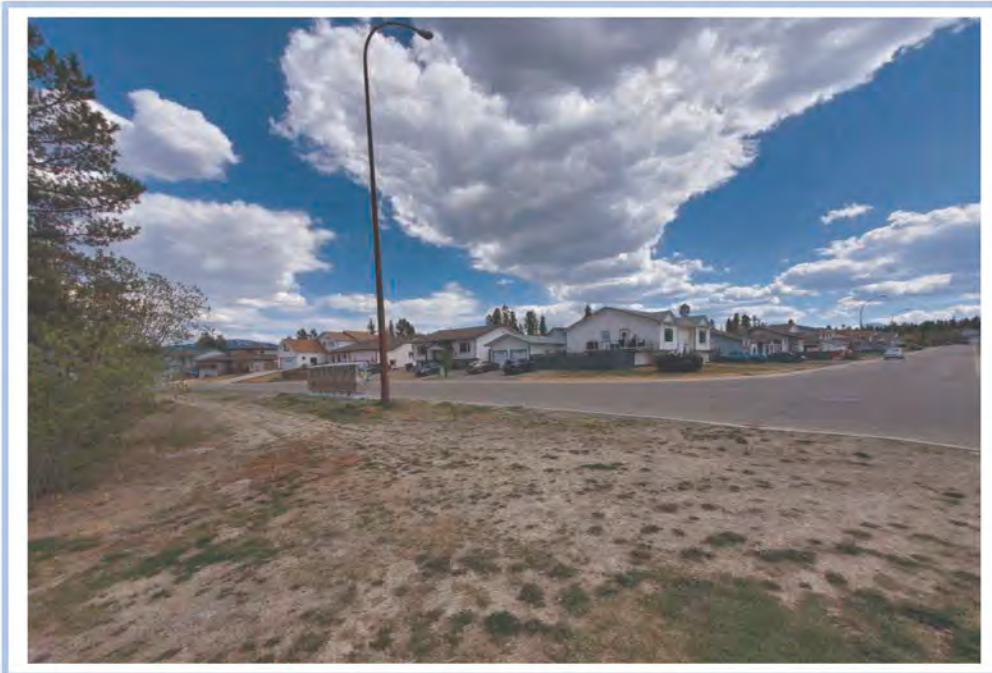
**Photograph 11:** Falcon Drive to the south, with residential buildings and Iron Horse Drive (looking southeast from the corner of the southwest Subject Site boundary) (June 3, 2022)

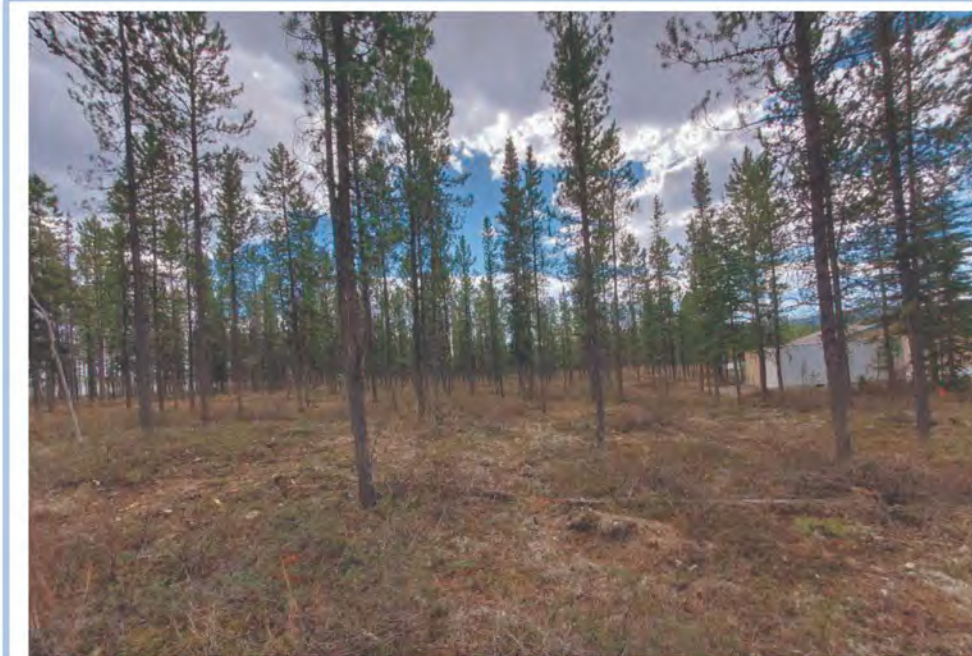
**Photograph 12:** view of the eastern portion of the Subject Site and Copper Ridge Place to the north (looking west from Diamond Way) (June 3, 2022)

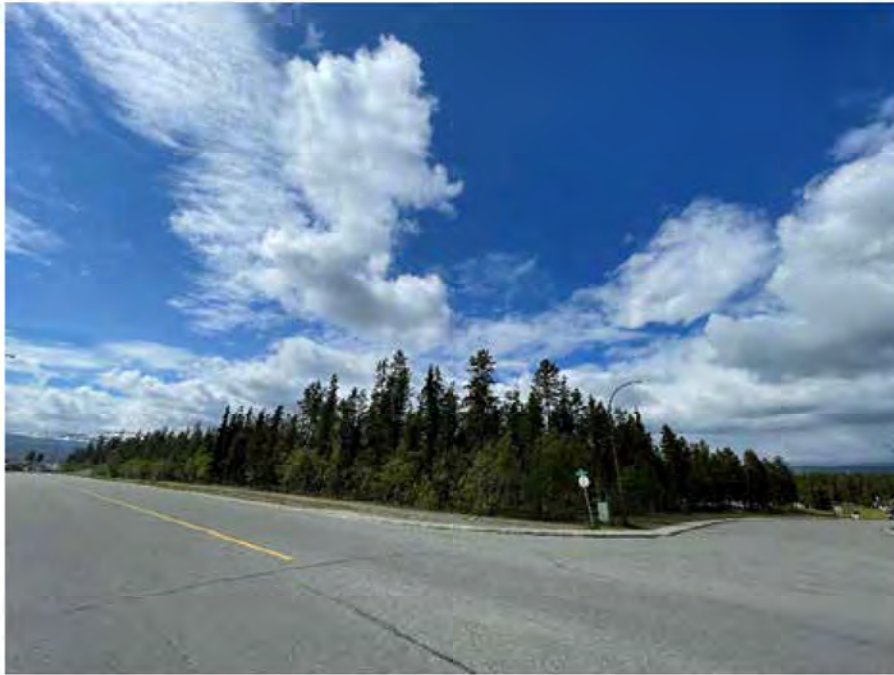
**Photo 1** View of vacant parcel site facing South-West during site visit (June 15, 2022).

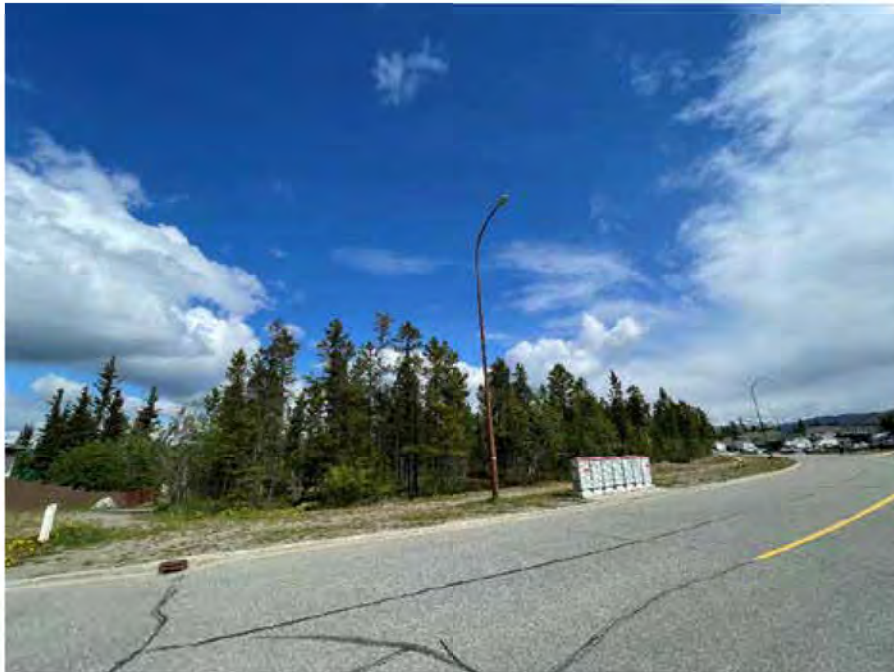
**Photo 2** View of vacant parcel site facing North during site visit (June 15, 2022).

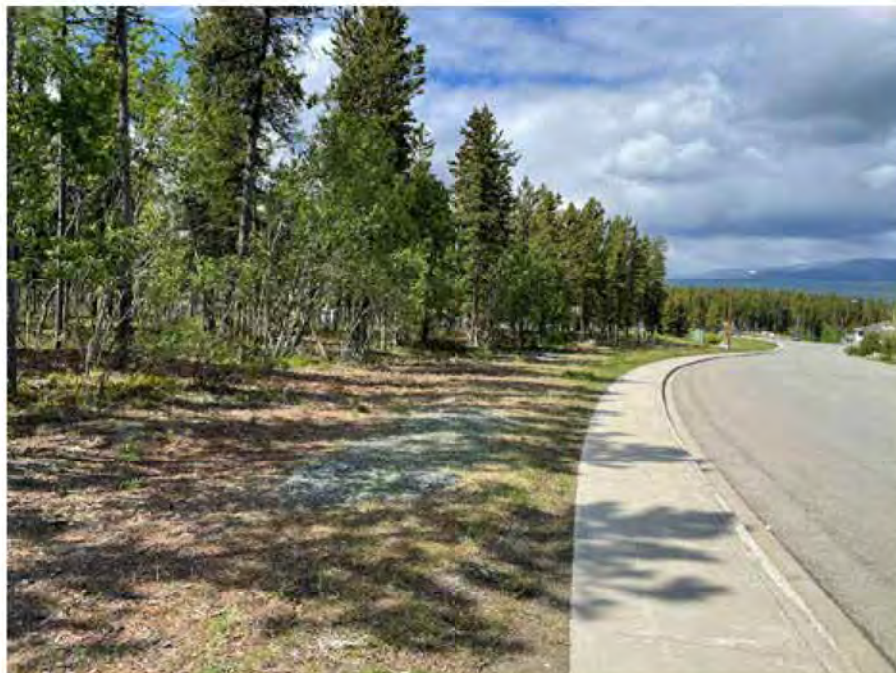
**Photo 4** View of North-East edge of vacant parcel site along Diamond Way during site visit (June 15, 2022).

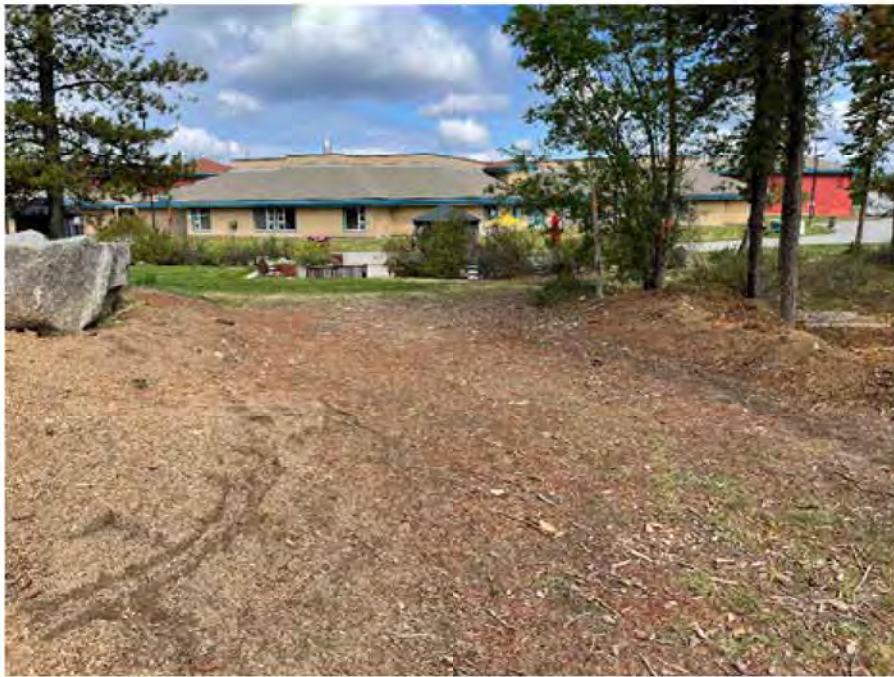
**Photo 5** View of North West side of vacant parcel site facing towards Copper Ridge Center during site visit (June 15, 2022).

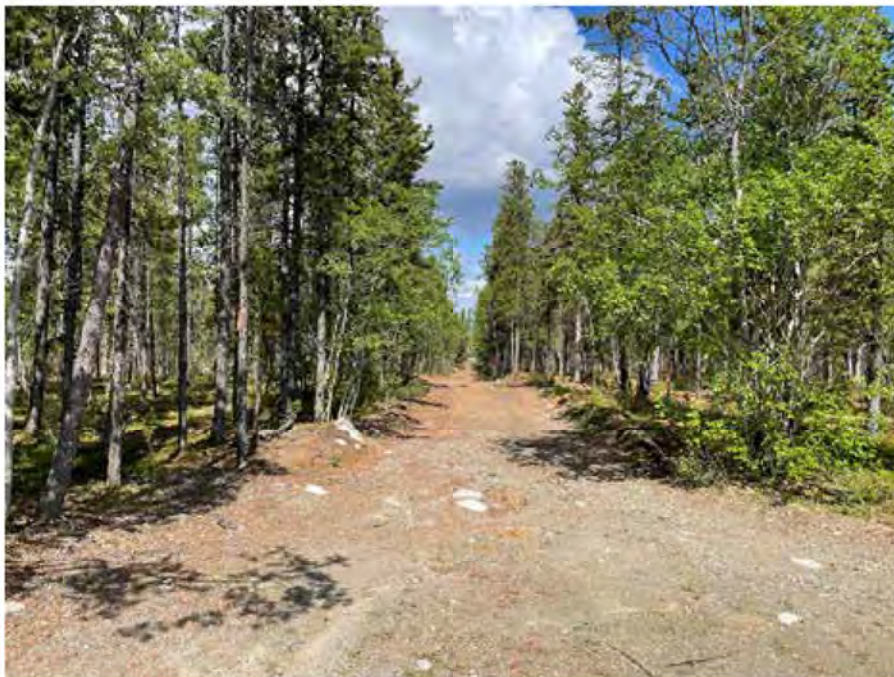
**Photo 6** View of cutline on vacant parcel site facing North-West during site visit (June 15, 2022).

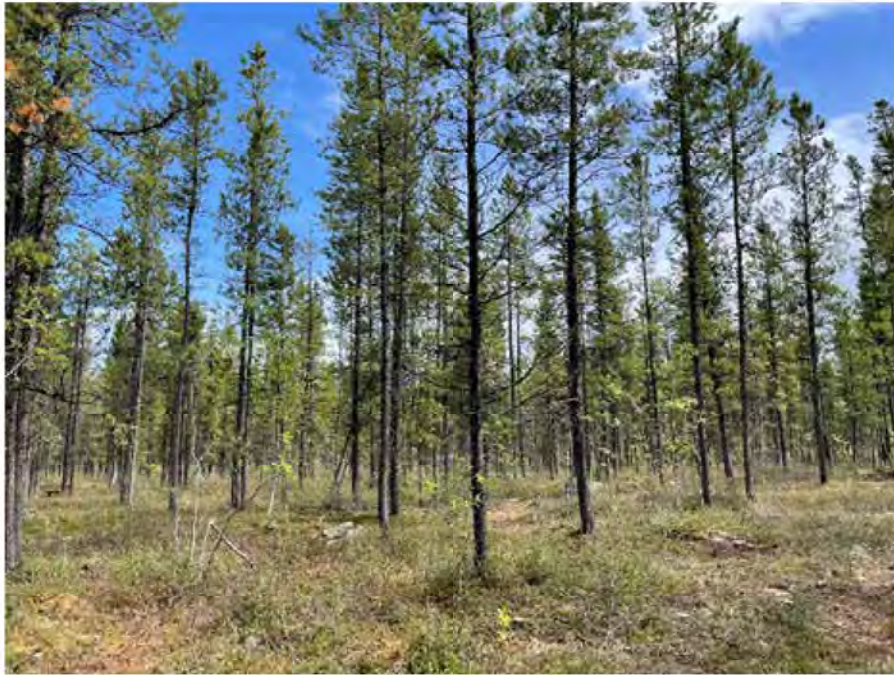
**Photo 7** View of vegetation on vacant parcel site facing North during site visit (June 15, 2022).

The Site is 5.9ha in size, unoccupied, with a downwards slope towards the North-West away from a high point in the middle of the east side. The vacant parcel is covered with spruce trees, pine trees, and some low-lying willows (Photos 7 in **Appendix A**). Other than recent fire smart maintenance it does not seem to have been previously disturbed except for a cutline that runs from Falcon Drive North northwest to the Copper Ridge Place Long Term Care Facilities and a narrow cutline running south from Diamond Way to Falcon Drive south of North Star Drive. The cutlines can be seen in aerial images before Copper Ridge was developed as far back as the 1980s. The Site is abutted by residential properties immediately to the west and urban roads to the north and east. To the northwest is the Copper Ridge Place Facilities and property. There is no commercial property in the area. A map showing the details of the surrounding properties is attached (**Figure 5**).

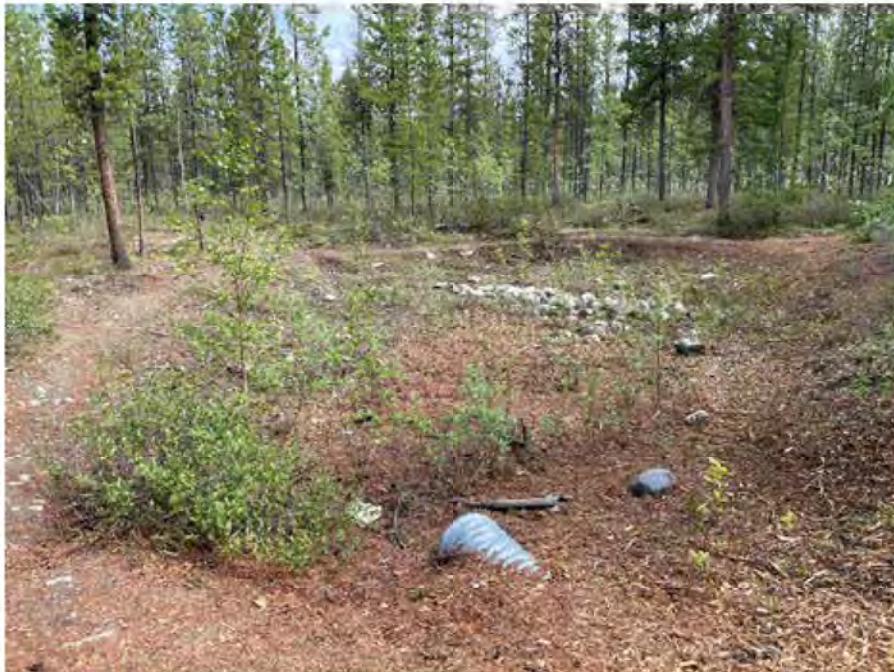
**Photo 8** View of infiltration depression on South end of vacant lot during site visit (June 15, 2022).

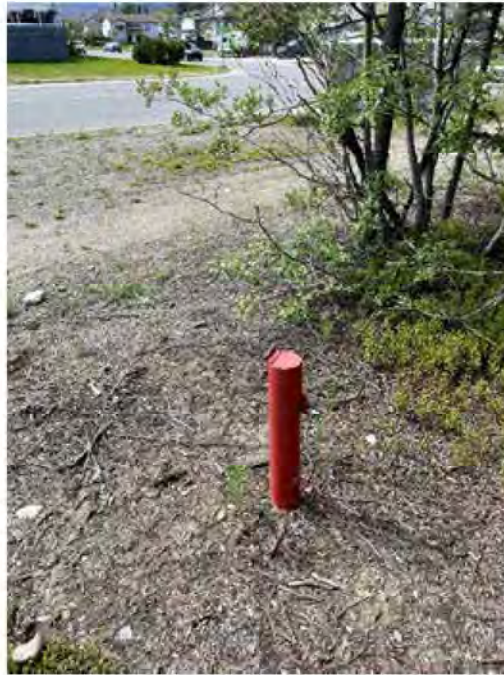
**Photo 9** View of stickup monitoring well on South side of vacant lot during site visit (June 15, 2022).

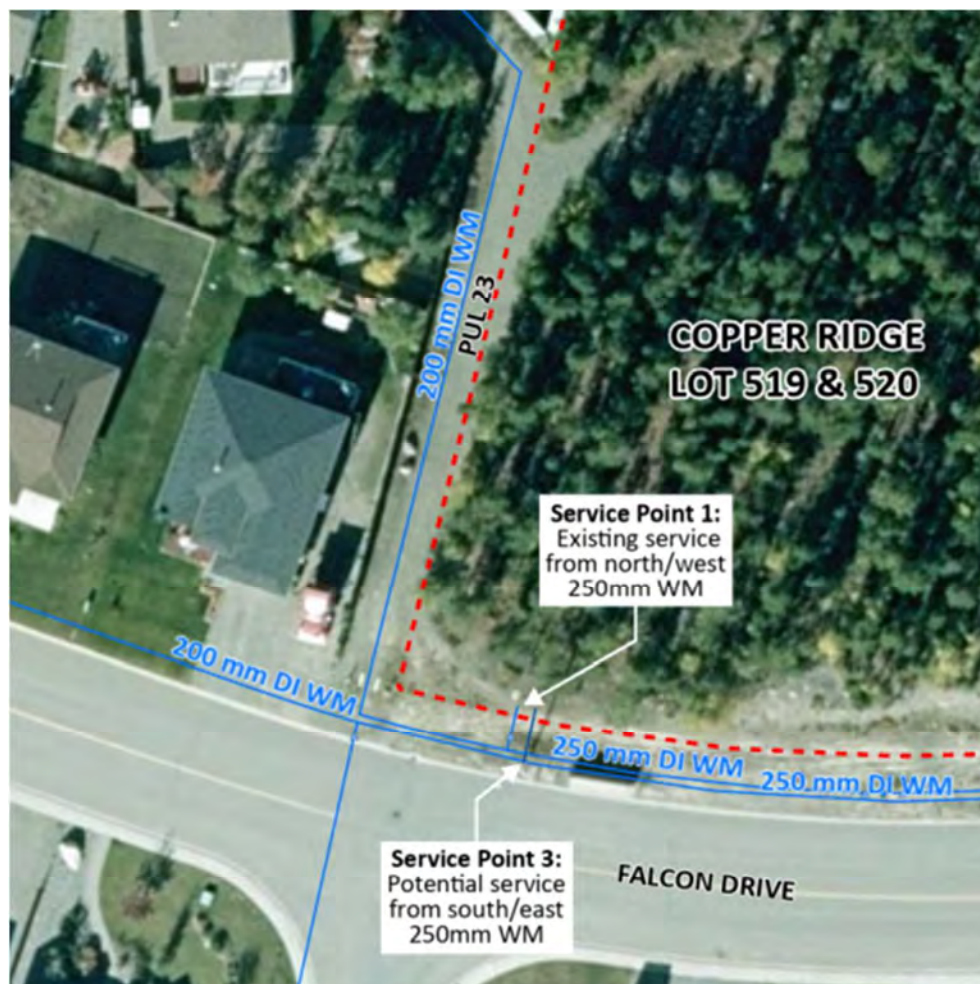
Figure 2-2A Existing watermains on Falcon Drive (between Iron Horse Drive and North Star Drive)

- A 250 mm ductile iron watermain on Falcon Drive approximately between the Copper Ridge Pump Station and Diamond Way. This watermain includes three services (considered as one service or 'Servicing Point 2') to the proposed development site, two of which are within 30 m of the Copper Ridge Pump Station and the final one, about 30 m south of Diamond Way.

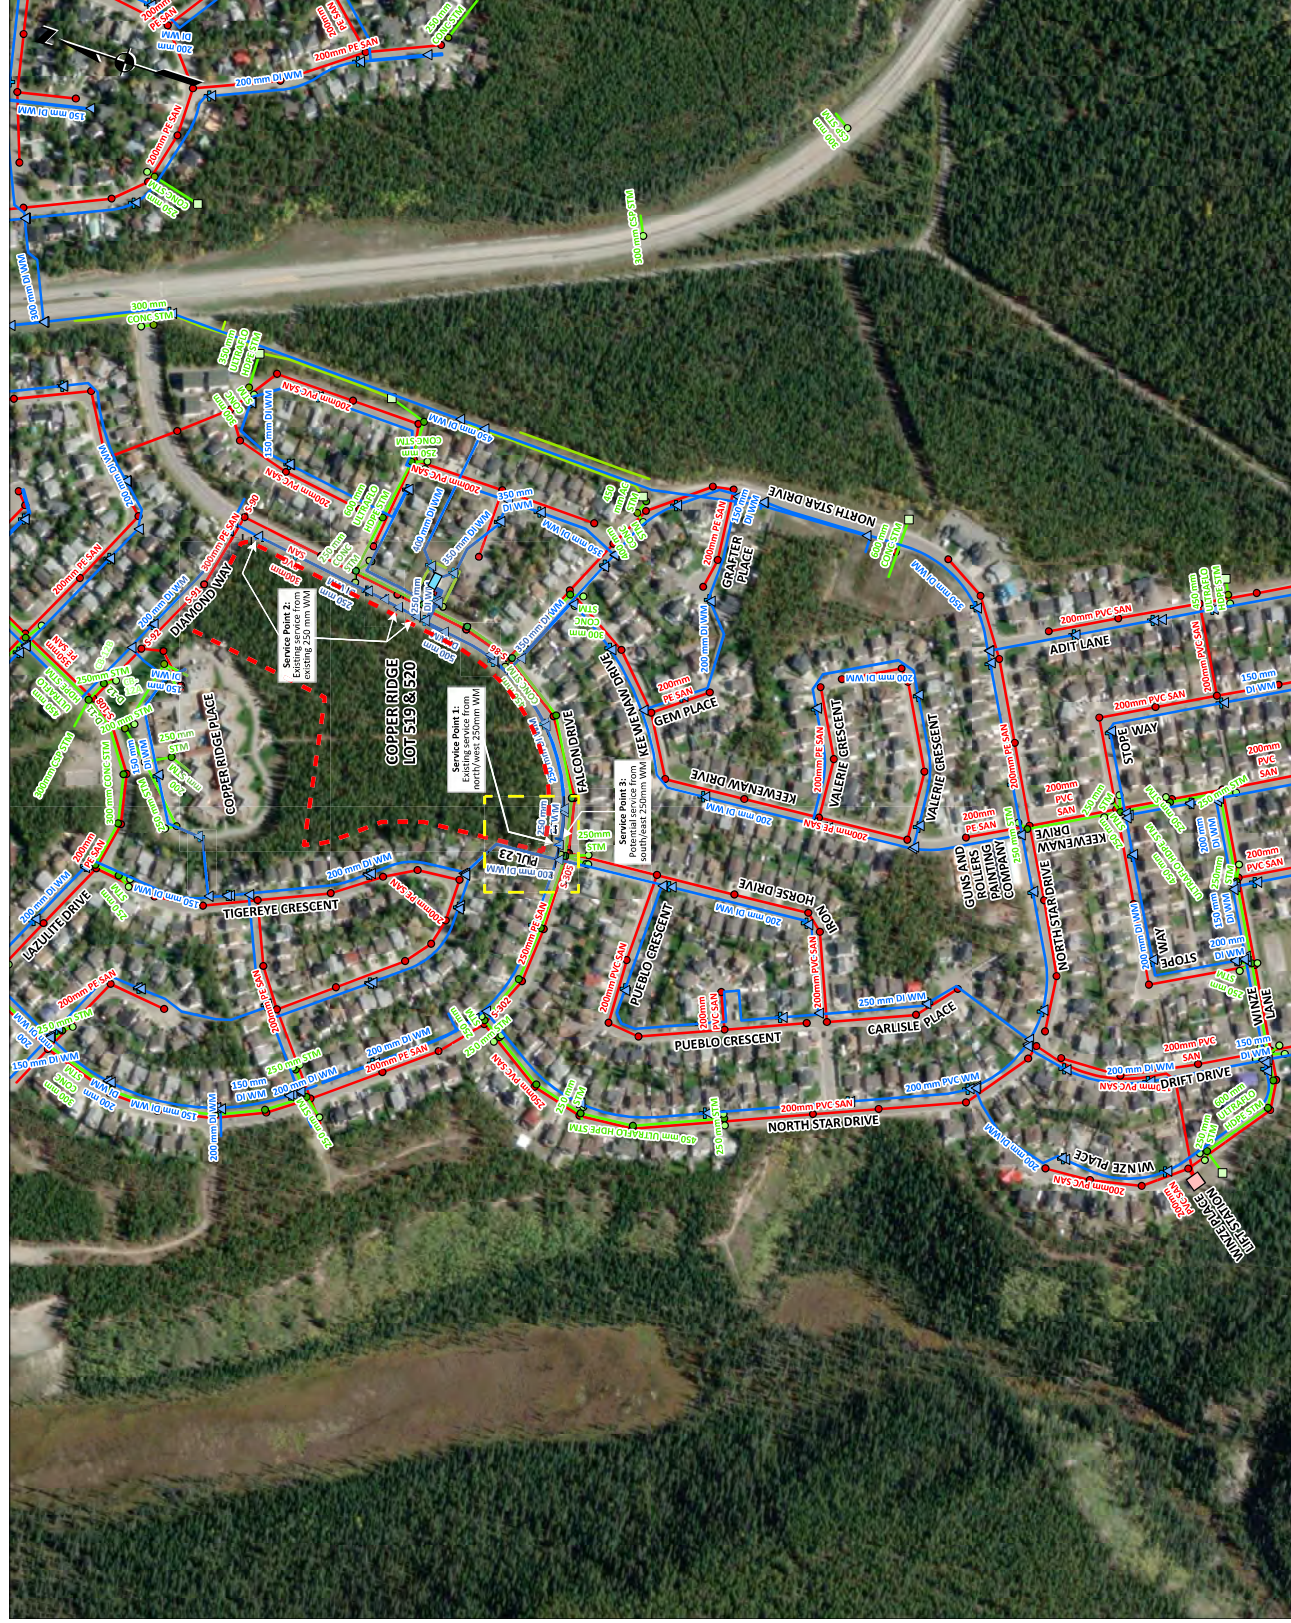
Figure 2-3: Copper Ridge Lot 519 & 520  
Existing Power Infrastructure

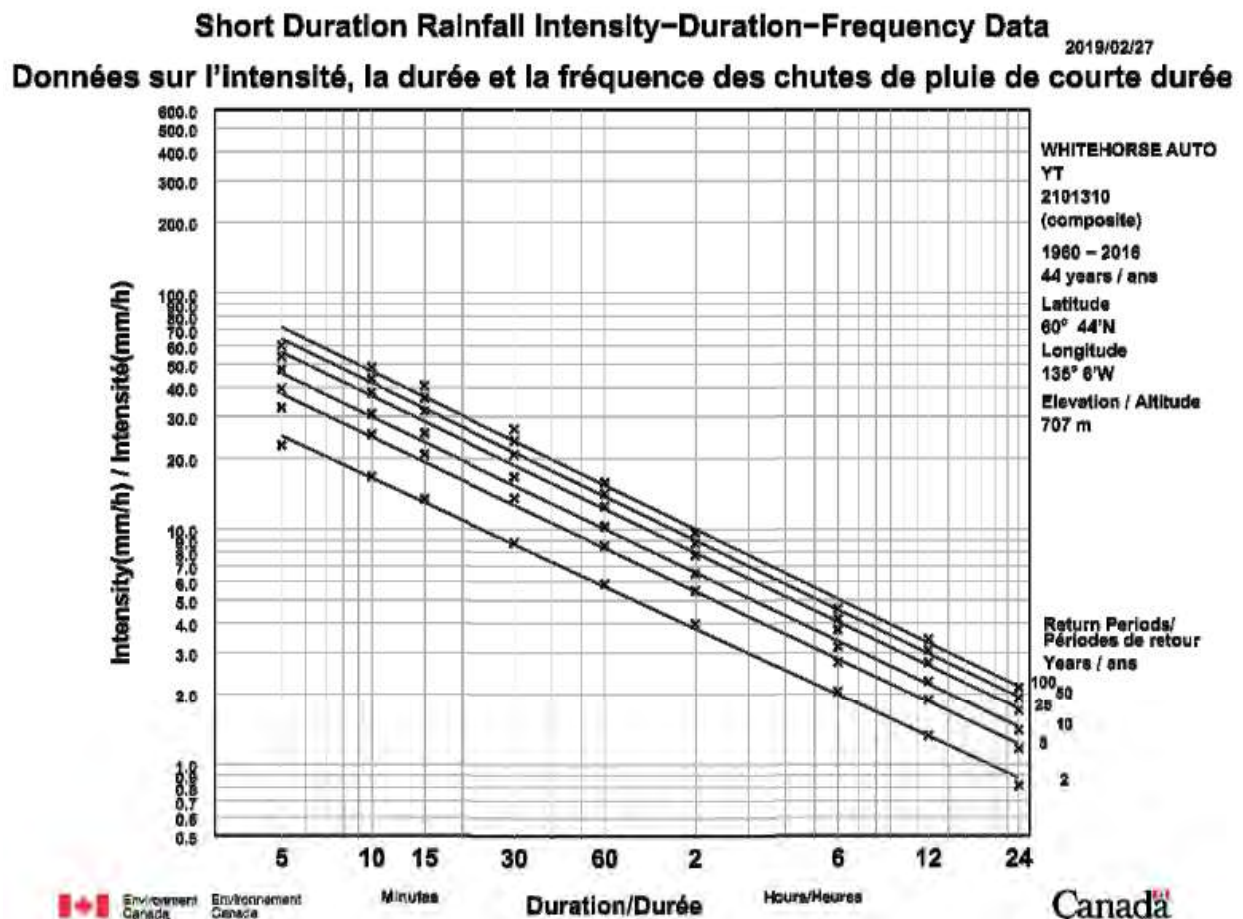
**Figure 1 Short Duration Rainfall IDF Data <sup>2</sup>**

The **Time of Concentration** at CB-12A is the inlet time of 15 minutes <sup>1</sup>. The **Intensity** was selected when the corresponding value for the **Duration** (i.e., Time of Concentration) lands on the line for the 5-year return period. Therefore, an **Intensity** of 19.41 mm/h was determined from **Figure 1**.

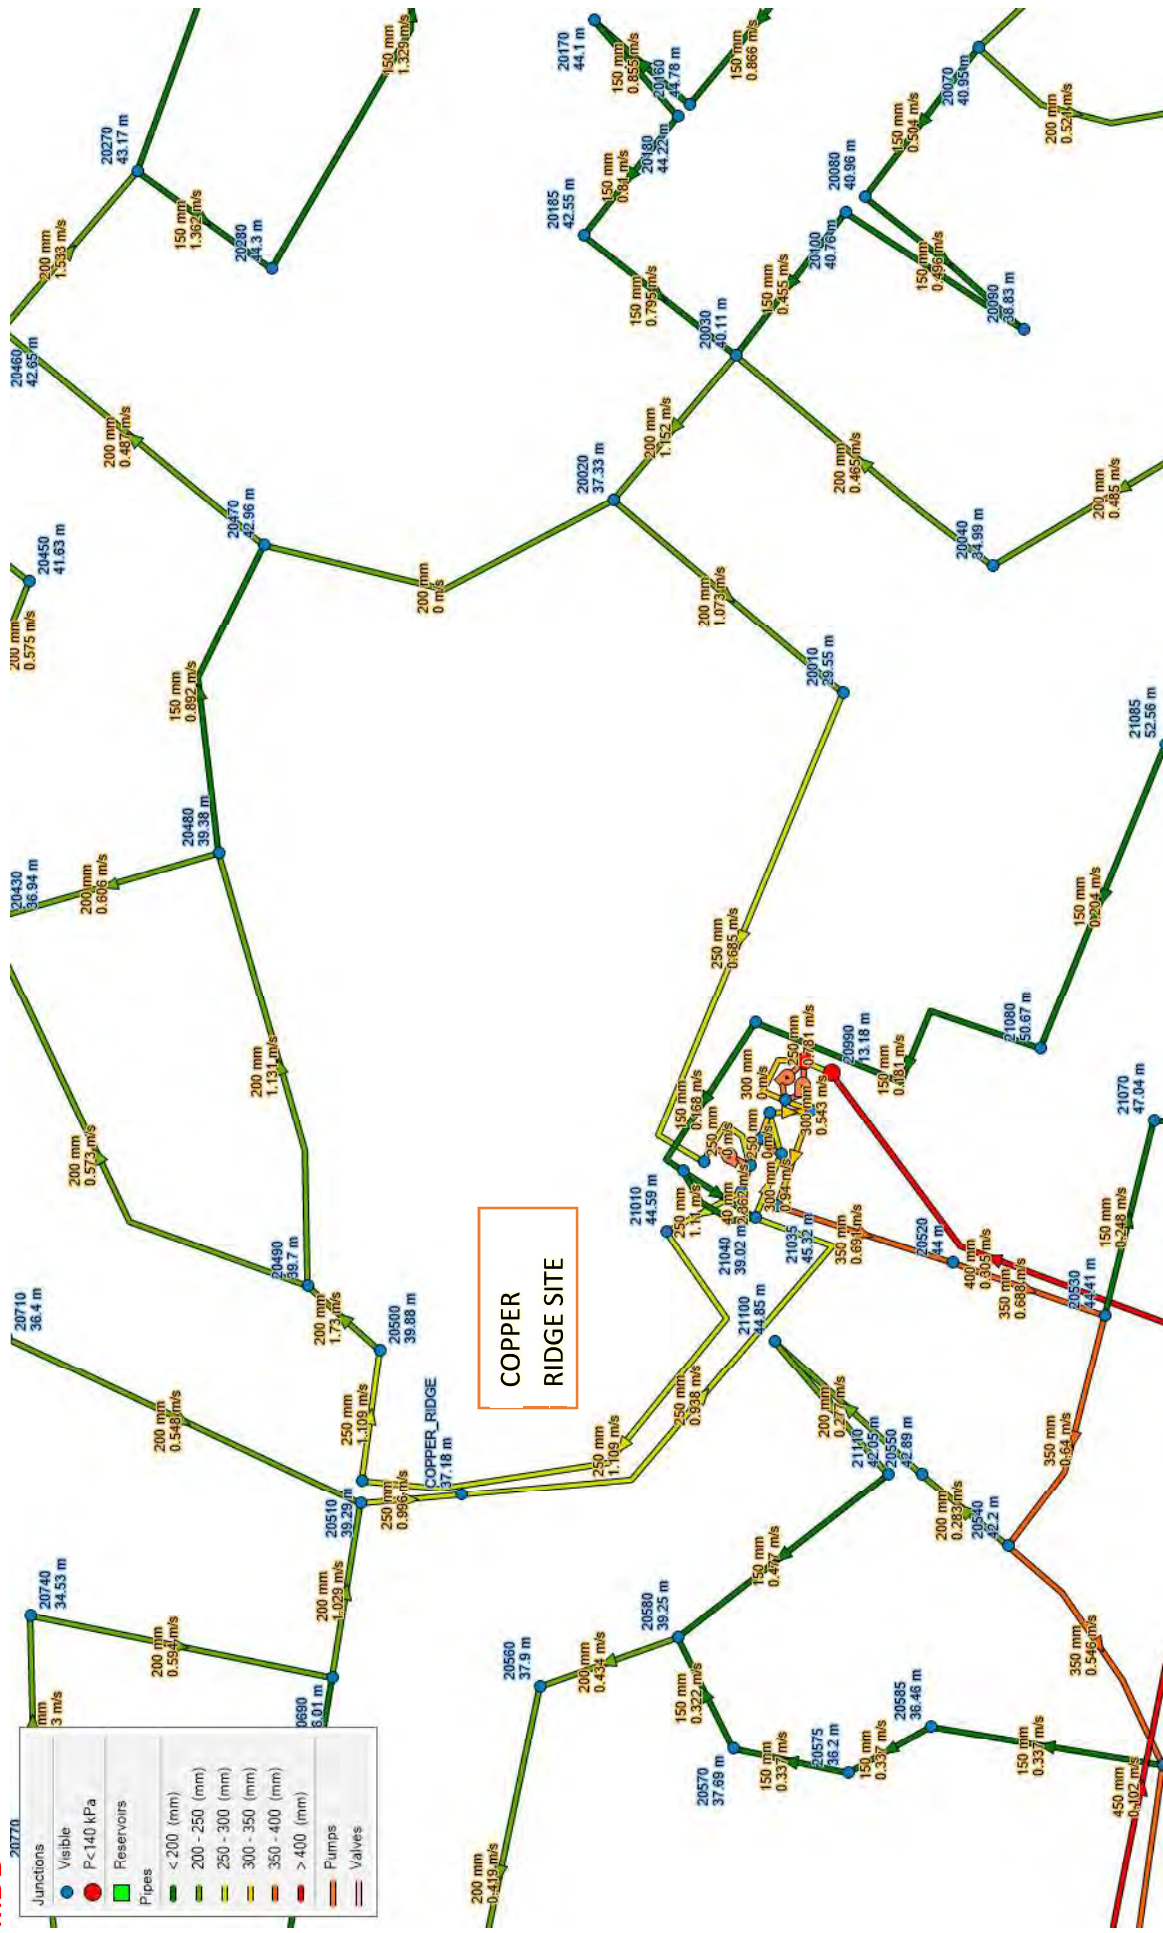
- Junctions:**
  - Visible: Blue dot
  - Pressure < 140 kPa: Red dot
- Pipes:**
  - < 200 (mm): Green
  - 200 - 250 (mm): Yellow
  - 250 - 300 (mm): Orange
  - 300 - 350 (mm): Red
  - 350 - 400 (mm): Dark Red
  - > 400 (mm): Brown
- Pumps:** Red line with a pump symbol
- Valves:** Red line with a valve symbol

- COPPER RIDGE SITE:** A central orange box indicating the location of the Copper Ridge Site.
- Flow Rates:** Labeled on each pipe segment, ranging from 0.083 m/s to 1.523 m/s.
- Elevations:** Labeled at each junction, ranging from 19.39 m to 50.3 m.
- Pipe Diameters:** Labeled on each pipe segment, ranging from 150 mm to 450 mm.
